# Engineering Instruction

No. MD /375  
ISSUE 2

**TITLE**  
REPAIR OF FRACTURED ALUMINIUM ALLOY LONGITUDINALS AND SOLEBARS,  
CLASS 108 DMU POWER CAR UNDERFRAMES.

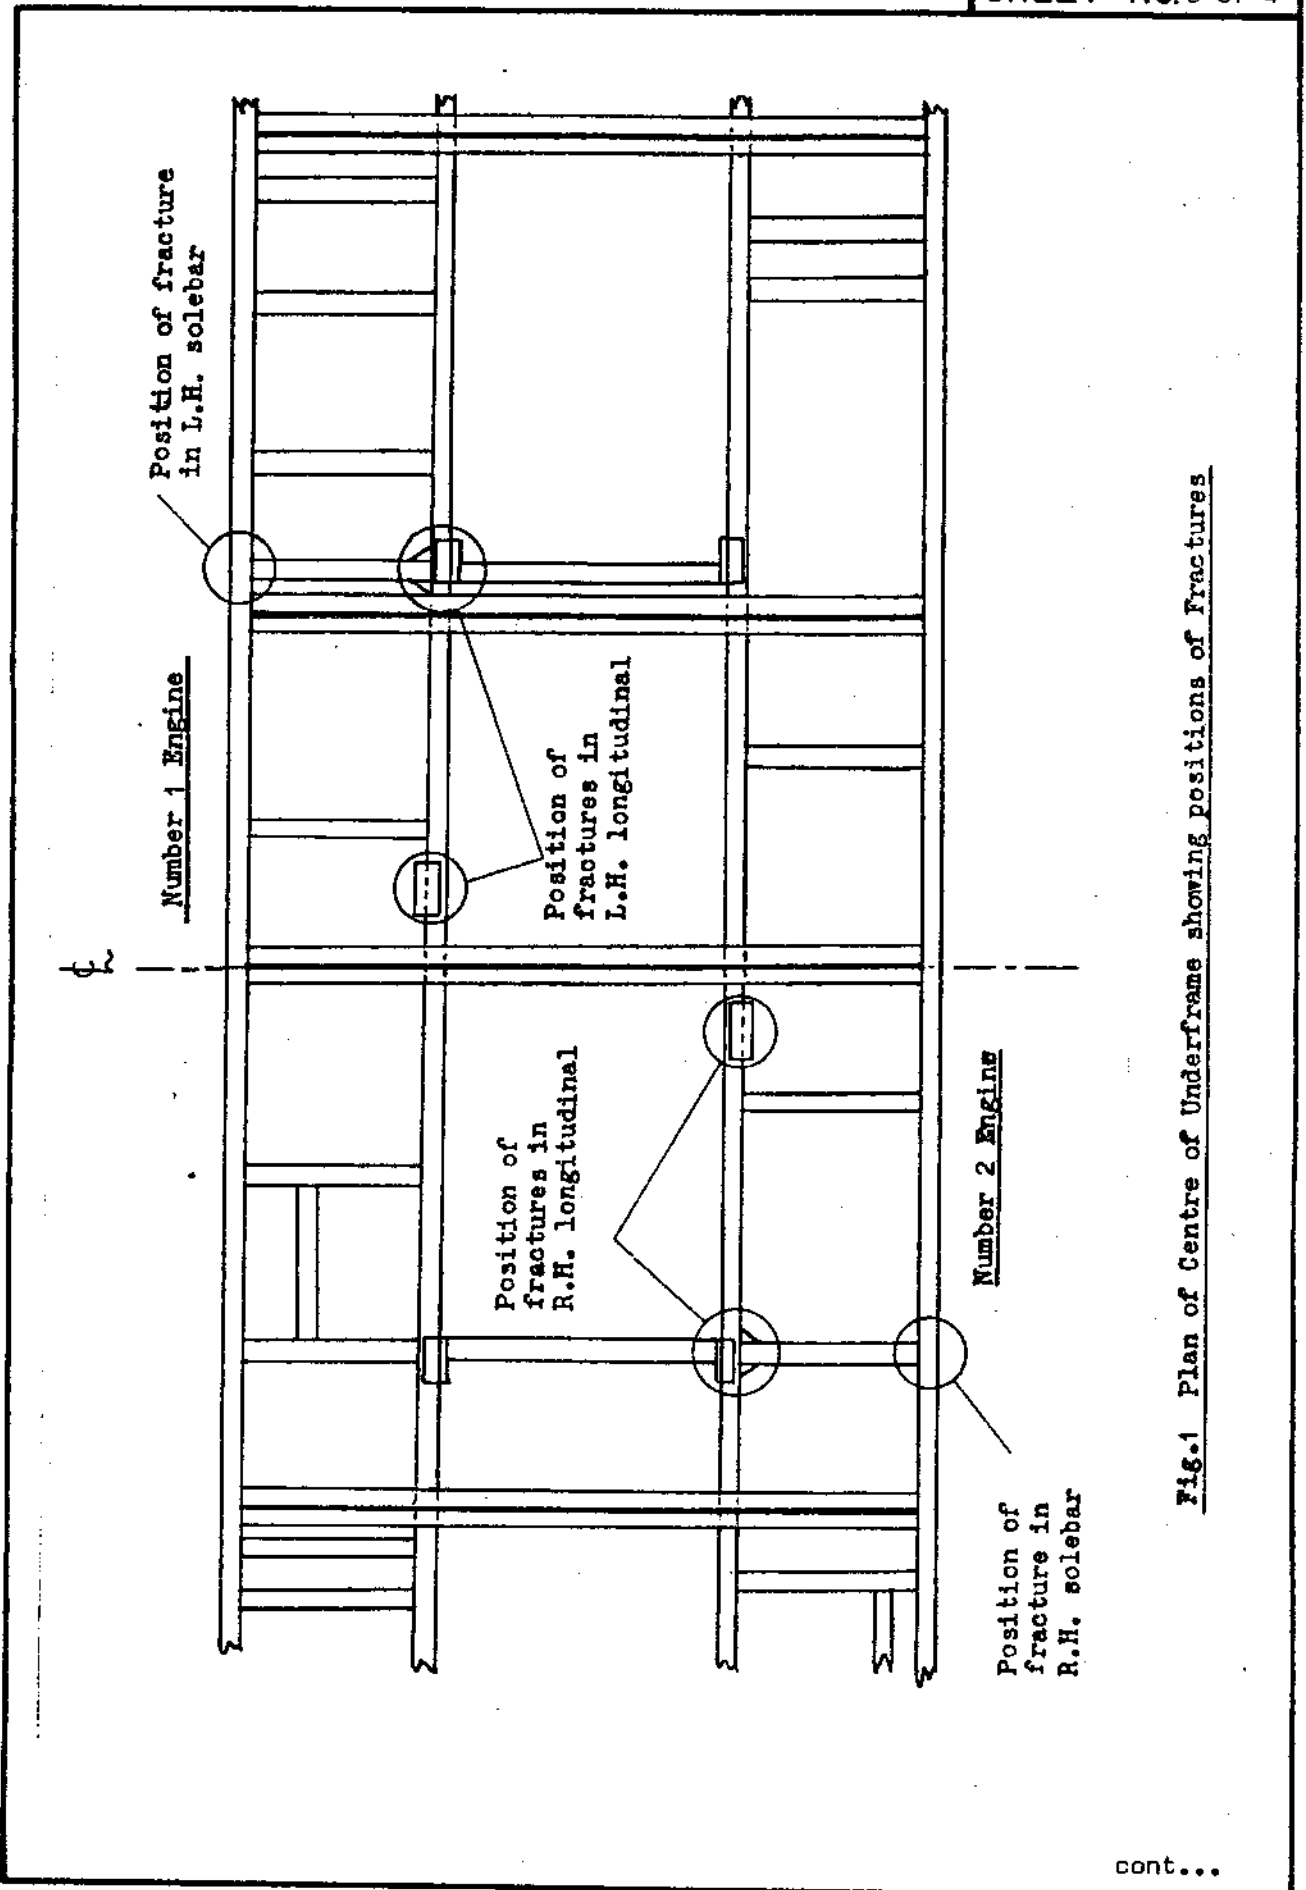
1.0 The aluminium alloy channel section longitudinals in the underframe of Derby Lightweight power cars are prone to fracturing in the vicinity of the engine front and rear mountings. Where longitudinals have fractured additional load is transferred to the solebars through cross-members and trimmers. This in turn can lead to fractures in the solebars, trimmers, and connecting knees.

Fig.1 Plan of Centre of Underframe showing positions of Fractures

2.0 During Main Works overhauls the critical areas shown in these Figures shall be crack detected using the dye-penetrant method. The examination is only to be carried out by operators approved by the Director of Mechanical & Electrical Engineering, BR HQ, Quality Assurance Division (refer to District Metallurgist).

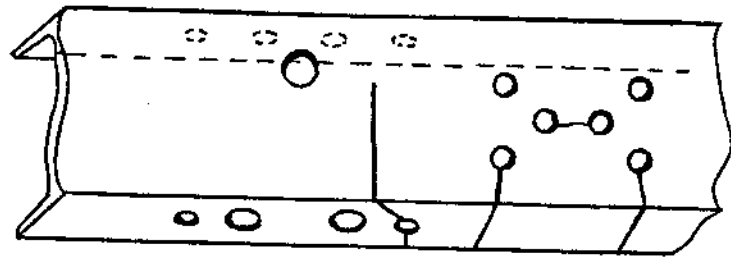
Fig. 2. Typical fractures in Inner Longitudinal;  
Position of Front Engine Mounting

- 3.0 Where such fractures are found the following methods of repair shall be adopted.
- 3.1 Fractured aluminium alloy longitudinals shall be replaced by a steel channel of the same section over a length that includes the positions of both front and rear mountings for the engine. BR Drawing B1-A0-9008221 shows the repair, specifies the replacement steel section, and gives the position, design, and fastening of the joints to be used to join the new steel section to the remaining aluminium alloy sections. The drawing gives only the important design requirements for the repair. The remaining details are left to the discretion of Workshop staff working to the guidelines given on the drawing and in association with the Resident Engineer, Q.A. Division, M & EE Department, BRB HQ.

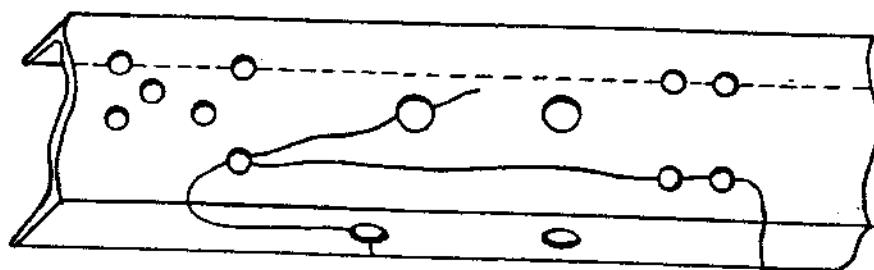
Fig. 3. Typical fractures in Inner Longitudinal;  
Position of Rear Engine Mountings

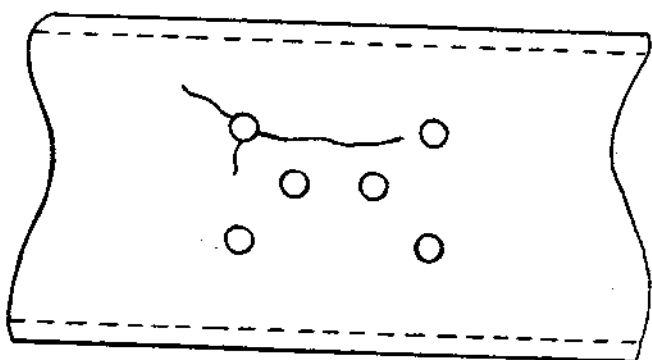
Fig. 4. Typical fracture in Solebar at position of connection  
with Engine Mounting Trimmer

- 3.2 Fractured solebars shall be repaired by drilling the ends of the cracks and fastening a reinforcing steel plate onto the outside of the solebar over the area of the fractures. The repair is fully specified on BR Drawing TBS-A0-9023769.
