EDITORIAL — Chris Walker

RESTORATION NEWS

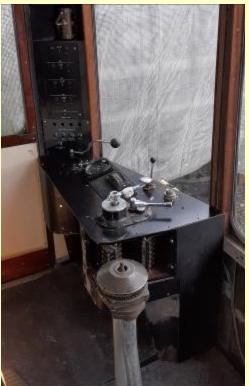
Views of the cab and control desk area of M79612 *Chris Lings*

M79612—In between working on the

Maintenance Shed Improvements and extension, I've managed to work on to the cab area of the trailer car. A lot of effort for not a lot of visible changes To make space for the windscreen demister duct, the first attempt at wiring terminal rails had to be relocated and the copper air pipes for the horn and wiper controls adjusted. Now I've rediscovered the cab desk drawing, I've been able to carry out some unmodifications from ultrasonic days back to more or less yellow diamond layout. The steel cladding around the gear controller (made by Tim Stubbs from an original he got out of a scrap Lightweight at Norwich many years ago) was fitted along with similar for the modified blue square throttle controller buried in the desk. All of the 'Bakelite' panels for the Driver's desk are now trial fitted. These were cut from sheets of 3.0mm Phenolic Paper from Attwater & Co which seems to be a good match. I've loosely re-assembled some of the desk in its unfinished state for photos (needs screw holes countersinking, steel panels finishing off and painting and the

minor job of wiring up and testing.

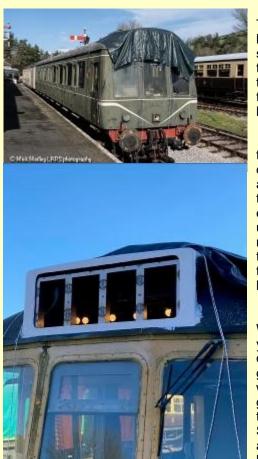
A prototype Headcode box has been made which needs modifications and gearing fitted before ordering blinds

The headcode boxes have been unblanked due to the panels leaking badly so the decision was made to remove them, make good and get Autoglass in to fit the glass with new rubbers, as they offer a lifetime warranty on it! so hopefully it'll be leak free.

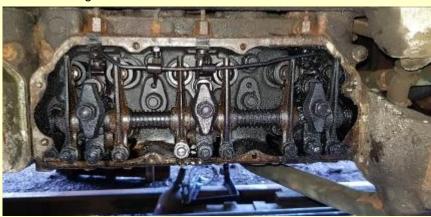
Below: 50632 No 2 engine rockers 3, 2 and 1. Chris Walker

A replacement engine is also required so attention was focussed on recently purchased 50632 which had two with the same mountings (680/1) Reliving things I hadn't done since my apprenticeship and after a number of obstacles overcome (Fuel Pump Control Rod stuck on one), the engines were slowly coaxed into life—oil bath air cleaners were removed and hot air blown into the intake as an incentive to start - they were not too happy after 12 years of idleness BUT start they did and we went home with a great sense of achievement.

Rocker Gear and Injectors were removed for inspection and cleaning-with three injectors not sealing on their Copper washers there was a lot of carbon to clean off before being re-assembled. No 2 engine now ran better than No 1 which decided it wanted to expel the contents of its sump when given some throttle. Having already. Advice was sought from a well known Midlands based friend and that encouragement together with setting the tappets ended with No 2 running beautifully albeit with a slight lubrication issue on 1, 2 and 3 rockers. Next on the cards is an oil flush and change.
