# ***The Railcar Association News Bulletin***

Welcome to Issue 125. Details are starting to be confirmed for the annual convention planned at the Llangollen Railway in Wales which also serves as a celebration of 60 years since the introduction of the pioneer First Generation sets, the Derby Lightweights. Hopefully the event will see strong patronage from the association, I hope to see as many groups and individuals from around the UK as possible there.

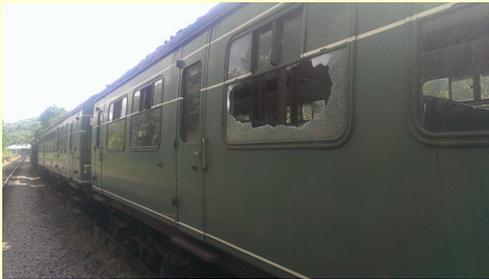
**North Yorkshire Moors Railway:** Sadly Class 101 [E59539](#) was vandalised whilst stored at Grosmont.

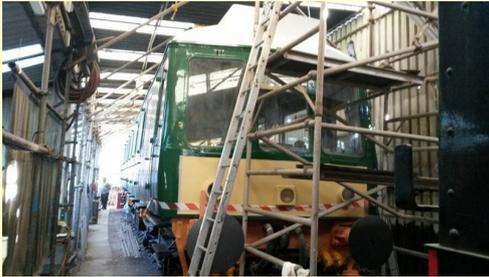
**Class 117 51365:** The vehicle is currently undergoing some restoration work inside the Plym Valley Railway's shed.

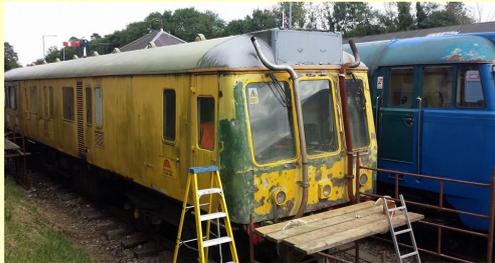
**Class 121 55029:** Exterior bodywork continues to progress. More and more of the Network Yellow is being lost as the areas of green primer and bodywork completion spread around the vehicle. The No2 end was being tackled during July & August.

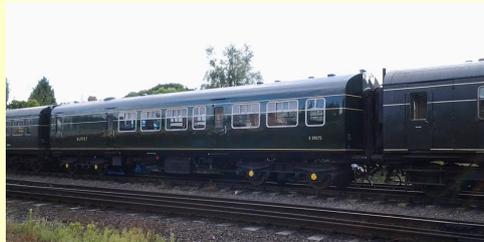
**Class 111 59575:** The vehicle was inserted into Class 101 set [E51427/E50321](#) during August for brake system and through wire testing. It is thought this was its first time in a DMU formation for 40 years. After a few pipes were tightened up, the test was declared a success.

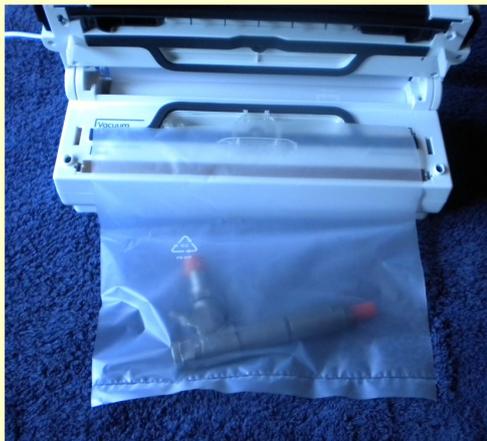
For the purpose of this test, an injector was selected. The

*The injector in its bag ready to be sealed*

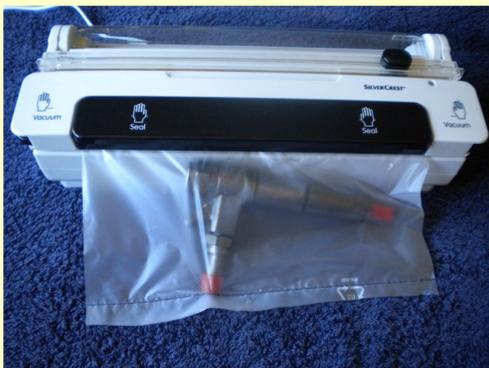
3) The injector was placed in the bag, and put the open end over the pump. Once the machine's lid was closed the air began to be sucked out of the bag

*Removing the air*

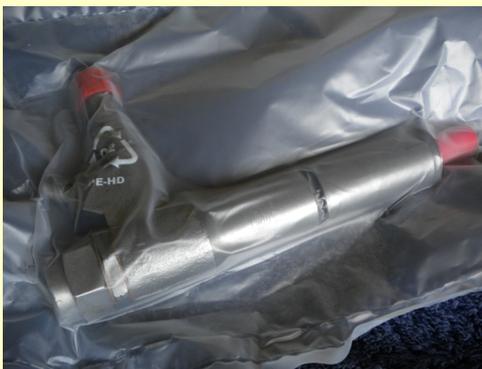
4) When all the air had been removed, the sealing strip was pressed and the bag sealed

*The finished item*

The size of the machine limits its use to smaller items, but corrosion will be inhibited as long as the seal remains intact. Adding a desiccant such as a sachet of silica gel would further protect items, as some air will remain in the bag. One further use of these machines has been found by classic car owners in the US. It is to pack roller bearings with grease! The bearing is packed in the normal way, then placed in the machine and the vacuum created draws the grease further into the bearing.

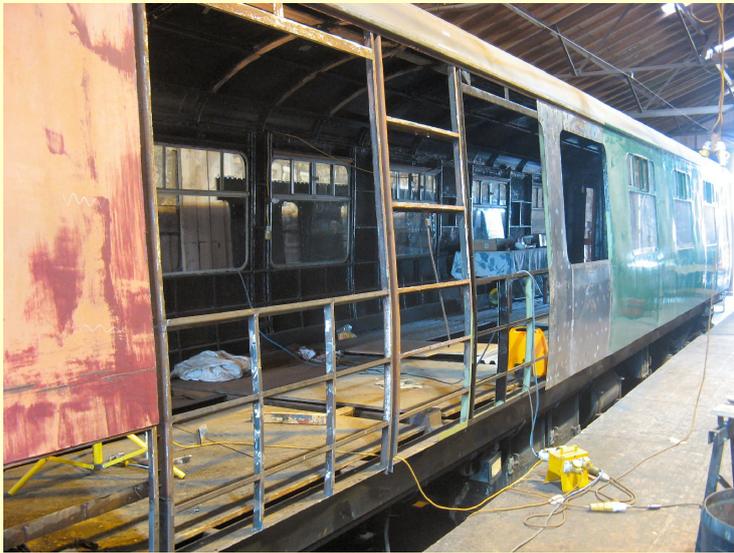
*Major bodywork progressing on Sc79943, 1/8/14 (J.Horne)*
